NSWC TR 85-388

EVALUATION OF THE LMA™ SERIES OF WIRE ROPE TESTING INSTRUMENTS

30 SEPTEMBER 1985

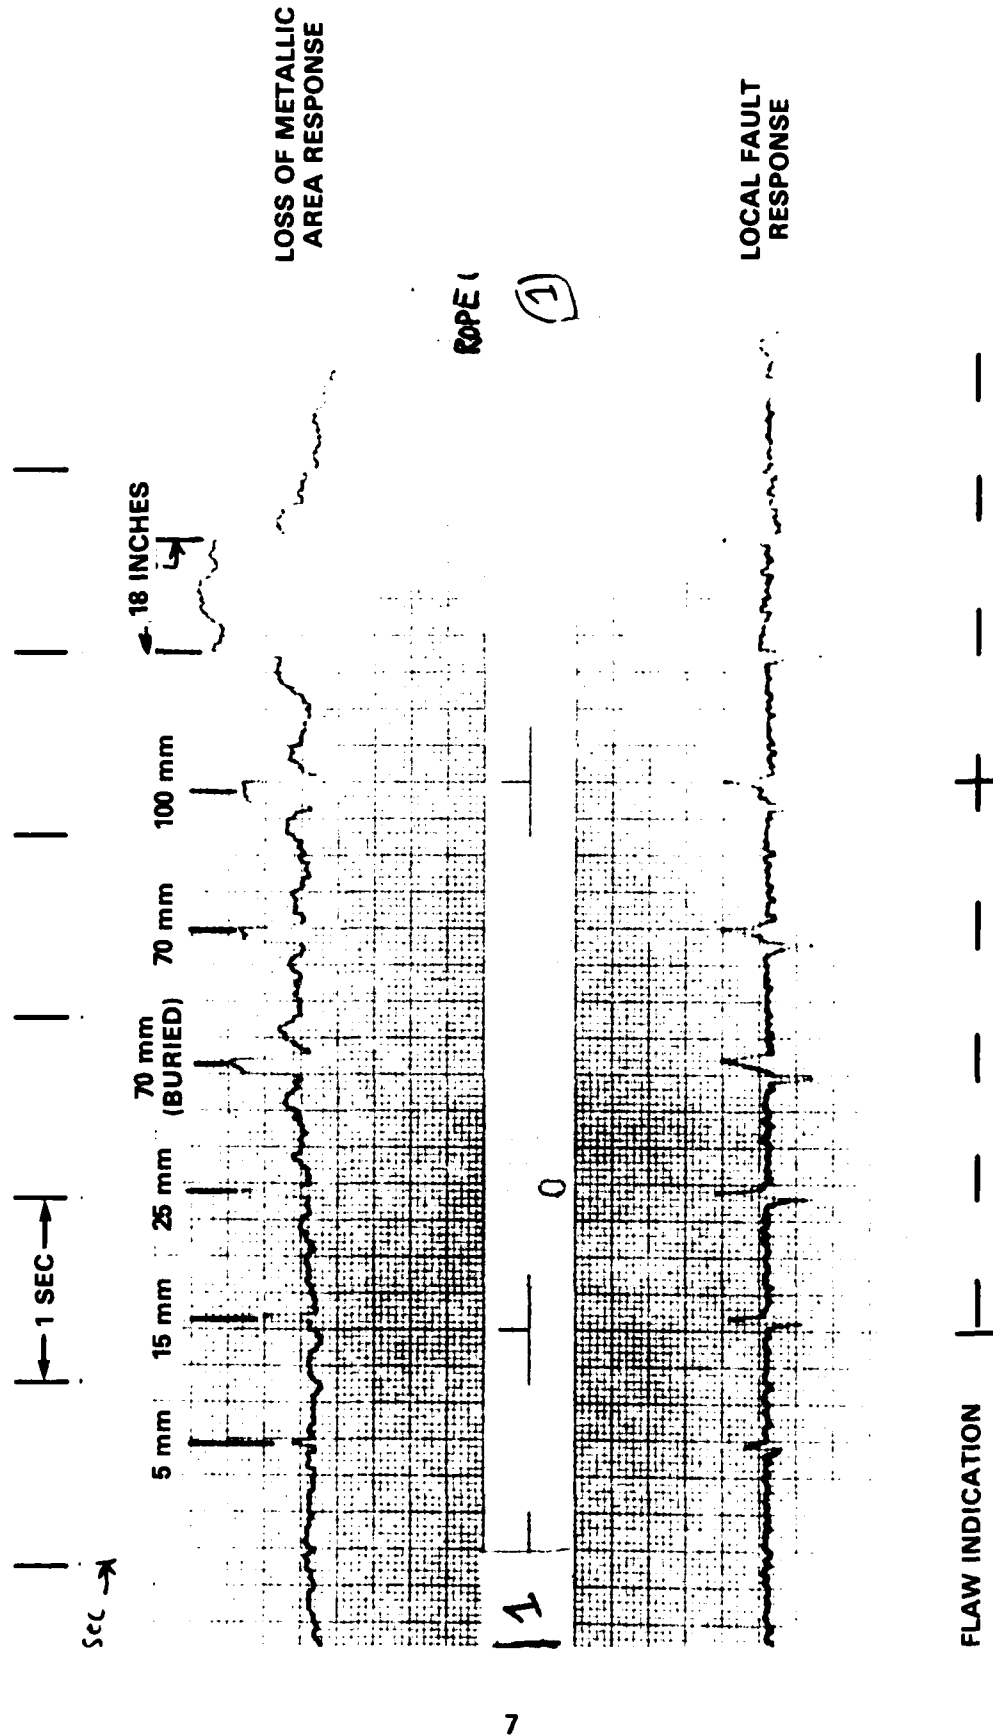
FIGURE 1A. RESPONSE OF LMA-125 TO SIMULATED DEFECTS IN A 0.75-INCH-DIAMETER, 6 x 19 FLOW-STEEL ROPE ON A TEST TRACK (DIRECTLY RECORDED DATA)

Figures 1A and 1B show the local fault and the loss-of-metallic-area signals for these defects. All of these defects are clearly indicated both on the local fault and on the loss-of-metallic-area channel. In this rope, the "rope noise" (background due to the texture of the rope) is well below the indication of a single missing wire. The sensitivity to the 70-mm defect is approximately the same whether it is buried or on the surface. The local fault indication is seen to be of opposite polarity at the beginning and at the end of the defect, both of which trigger the flaw indication at the bottom trace since the threshold has been set appropriately. (The flaw indication ignores the sign of the local fault response.)

This data gives confidence as to the detectability of a gap as small as 5 mm in a single wire. The rope noise of this rope is well below the indication of a single missing wire. The loss-of-metallic-area channel has more than adequate sensitivity. Baseline drift is a problem, however. Even this short record shows a slight drift; in 13 feet of travel, the baseline of the LMA channel shifts by a fifth of the indication of a single missing wire. This problem has been noted on instruments of other manufacturers.

The tape recorder interface faithfully reproduces the data as can be seen by comparing Figure 1B, which is the playback of a recorded signal, with Figure 1A, which is recorded directly from the LMA-125. On playback, the scales and offsets could have been adjusted to suit the operator's needs. The data quality is maintained and is independent of recorder gain since an fm modulation scheme is employed at the interface.

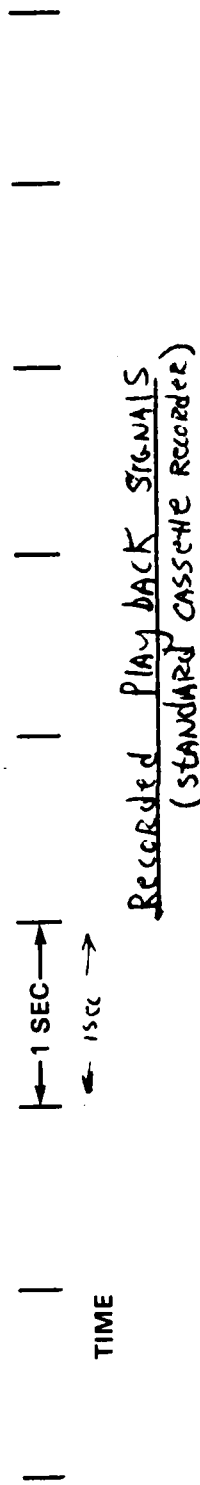
LOSS OF METALLIC
AREA RESPONSE

LOCAL FAULT
RESPONSE

FLAW INDICATION

FIGURE 1B. RESPONSE OF LMA-125 TO SIMULATED DEFECTS IN A 0.75-INCH-DIAMETER, 6 x 19
PLOW-STEEL ROPE ON A TEST TRACK (DATA PLAYED BACK
FROM MAGNETIC CASSETTE)

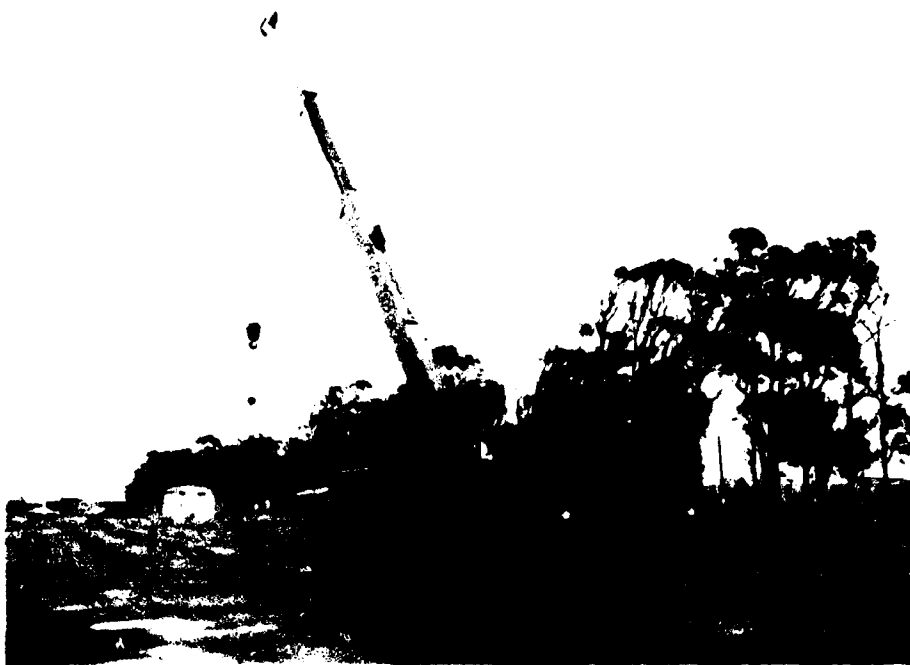
FIGURE 2. PETTIBONE 50TK CRANE USED FOR EVALUATING THE LMA-75 AT PORT HUENEME, CA
(NOTE: THE ROPE OF THE 6-PART LINE ASSEMBLY WITH THE BLOCK AND TACKLE
WAS INSPECTED.)

Tests were also conducted using the LMA-75 on a PETTIBONE 50TK crane at Port Hueneme, California. It was equipped with a 5/8-inch, 6 x 25 IWRC rope, rigged in a 6-part line. This crane is shown in Figure 2. The actual testing is shown in Figures 3 to 5. The only load was the ball and hook. The rope was in fair shape, and about 12 indications were noted in around 400 feet of rope. The drum diameter was smaller than on the MANITOWOK crane and about 20 to 30 percent of the indications proved to be external, as expected. Unfortunately, the rope was still in active service and the operator did not want us to open it up with a Marlin spike to examine the interior.

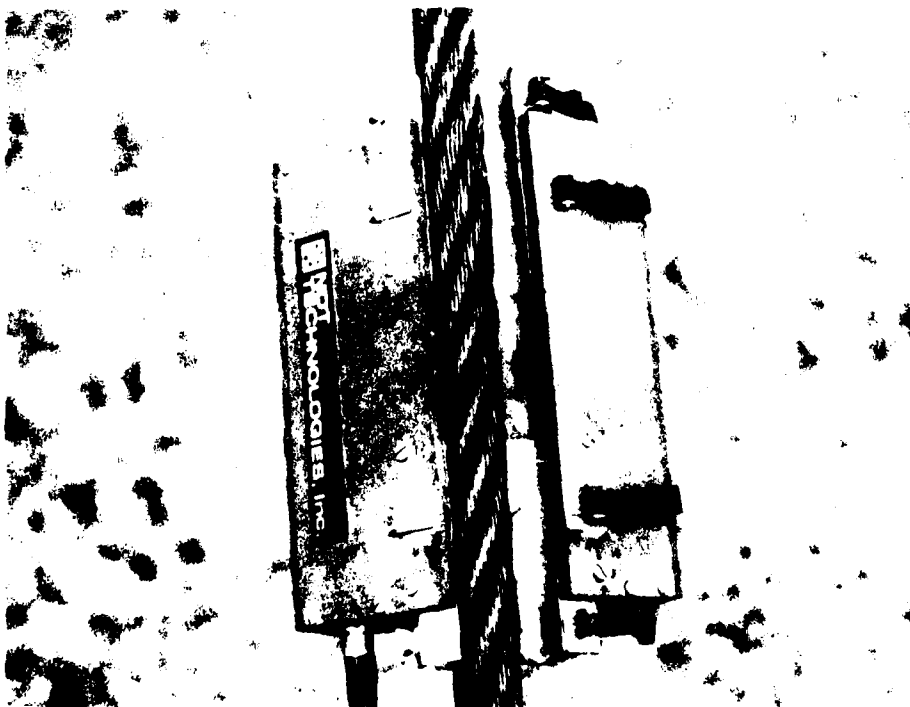
FIGURE 3. THE LMA-75 IN PLACE ON A WIRE ROPE WITH THE INSTRUMENT HINGES OPEN

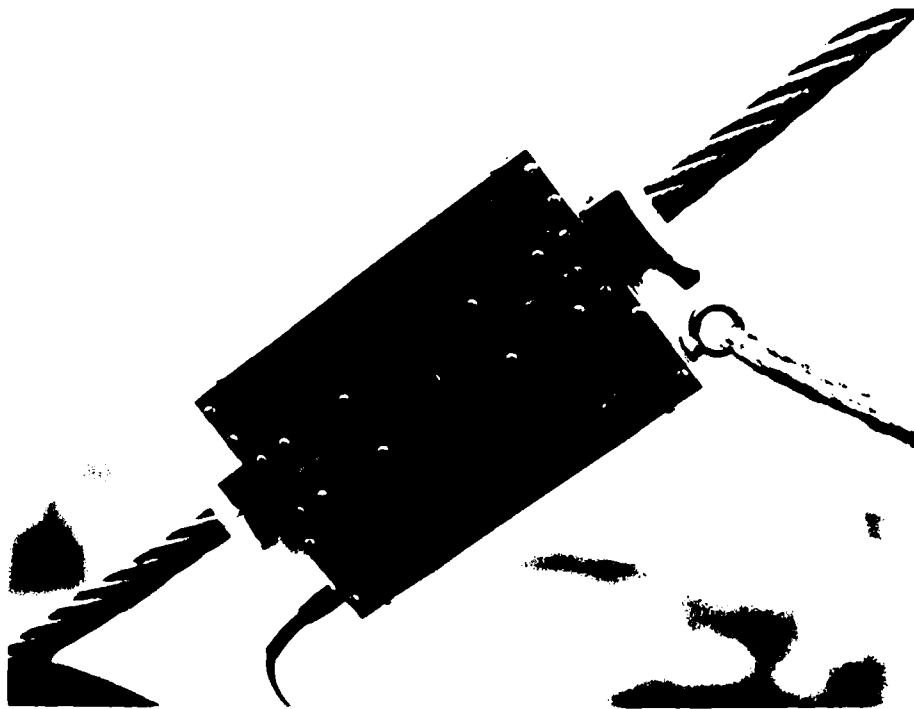
FIGURE 4. THE LMA-75 IN PLACE ON THE WIRE ROPE NEAR THE DRUM WITH THE INSTRUMENT HINGES CLOSED
(NOTE: THE ROPE TETHER (LOWER RIGHT) SAFELY HOLDS THE INSTRUMENT IN PLACE WHILE ALLOWING IT TO FOLLOW THE DRUM WINDINGS. ELECTRICAL CABLE EXITS THE INSTRUMENT AT THE BOTTOM OF THE PICTURE.)
